Project Experience Oil and Gas Atlantic LNG – Trinidad & Tobago

Supply of MCU Coating for recoating of 80,000 sqf storage tank roof

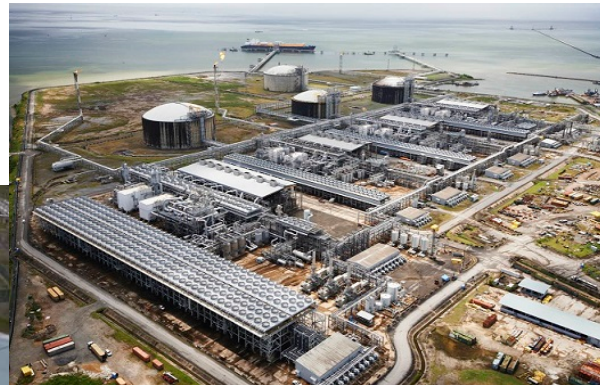
Surface Preparation – Wet abrasive blasting

MCU System – Miozinc @ 5-6 mils dft & topcoat @ 2-3 mils dft

Project was completed in recording breaking time when compared with previous use of traditional 3 coat epoxy & PU system, high humidity, adjacent flare and marine conditions. Topcoat was applied 3 months after final primer application. MCU is now specified for ALL four LNG storage tank dome.

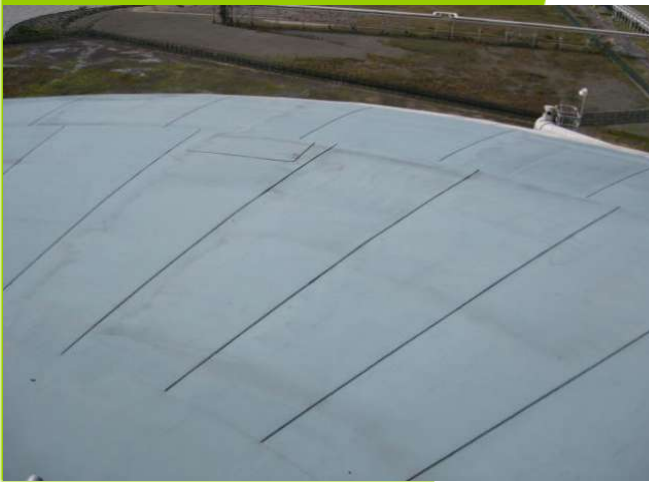
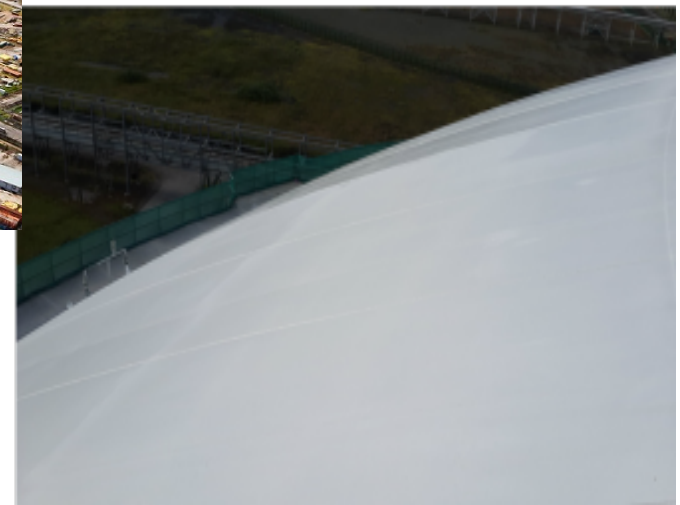
**Inspected after 4 years
with
NO corrosion or
adhesion failures**
